Landwind CV9

Landwind CV9 2.0, LHD

2010 ★★☆☆☆

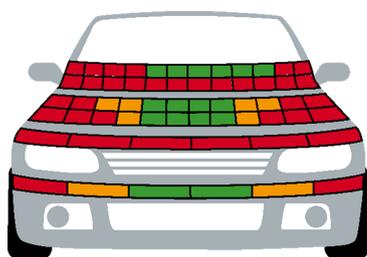
PEDESTRIAN

HEAD 7,4 pts
PELVIS 0 pts
LEG 3,9 pts

The protection offered by the bumper to pedestrians' legs was good in places and poor in others. The front edge of the bonnet offered poor protection and scored no points in Euro NCAP's tests. Tests in some areas at the centre of the bonnet indicated good protection for a child's head but was poor elsewhere. The protection offered to the head of a struck adult was also predominantly poor.
