Club Car Villager 2+2 LSV

All-electric, 4 seat heavy quadricycle

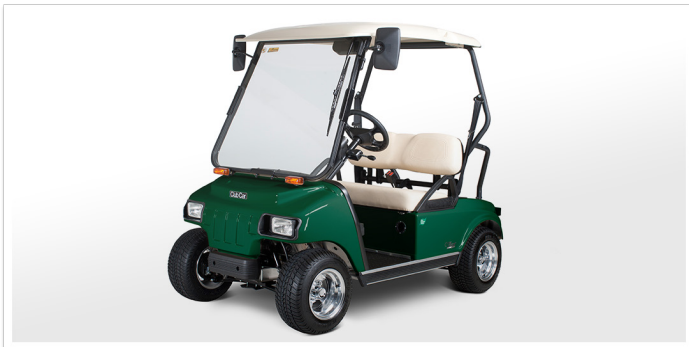
FRONTAL 2.0 pts (of 16)

The maximum speed of the Club Car is 40km/h so a frontal impact at 50km/h represents a collision with another vehicle. In the frontal impact, the structure of the Club Car collapsed. The steering wheel moved rearwards by nearly half a metre. The dummy's head hit the steering wheel and the values recorded indicated a very high risk of fatal injury. The chest pressed against the steering wheel, taking most of the force of the dummy. As a result, there was relatively little force on the seatbelts and they, and their connection to the rear pillar, stayed intact during the impact. The seat base hinged forwards in the impact and this, combined with the intruding instrument panel, led to the tops of the dummy's tibias striking the facia, leading to very high displacements in the knees. Protection of the knees and femurs was rated as poor. In the side impact, there was nothing to protect the dummy from the striking barrier. The driver's seat became detached from the structure and moved sideways, together with the lower part of the test dummy.

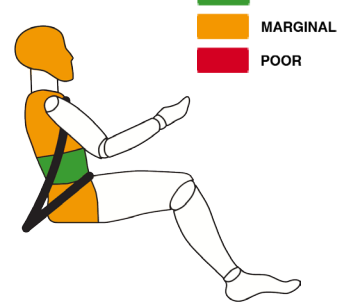
SIDE 9.0 pts (of 16)

No airbags are available on the Villager 2+2 LSV. The seatbelts did not break or detach in the frontal test as most of the force was taken by the intruding steering wheel. In the side impact, the head of the dummy was exposed outside the structure of the vehicle, increasing the risk of dangerous head contact in real-world accidents, and the score was penalised.
