Mercedes-Benz CITAN Kombi

Mercedes-Benz CITAN Kombi, 109 Blue Efficiency 'High' grade

2013 ★★☆☆☆

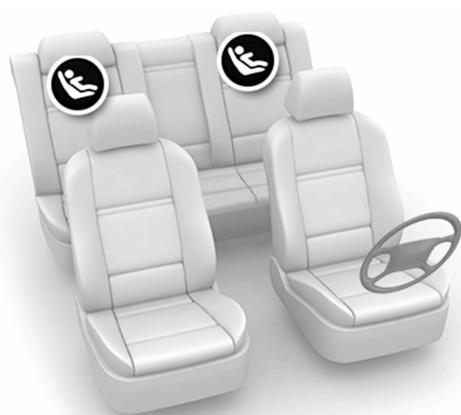
CHILD SAFETY FEATURES AND CRS INSTALLATION CHECK

Isofix

Safety features score **3 pts**
Installation check score **7,1 pts**

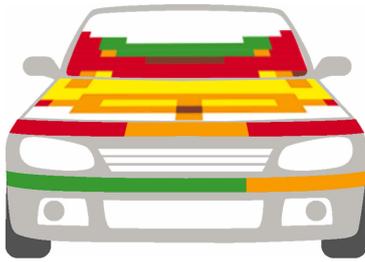
PEDESTRIAN

- GOOD
- ADEQUATE
- MARGINAL
- WEAK
- POOR

HEAD	14 pts
PELVIS	0,5 pts
LEG	5,9 pts

The bumper was predominantly good but the front edge of the bonnet provided poor protection in most of the areas tested. Adequate protection was provided by the bonnet over much of its surface but protection in those areas where an adult's head might strike was mostly poor.
