Produced in association with WHATCAR?

EURO NCAP 3

tow the tests were done

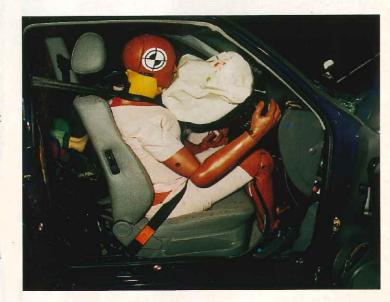
Top Hybrid III is strapped into the driver's seat of the car for the test Above No instrumentation is fitted into the dummy's arms

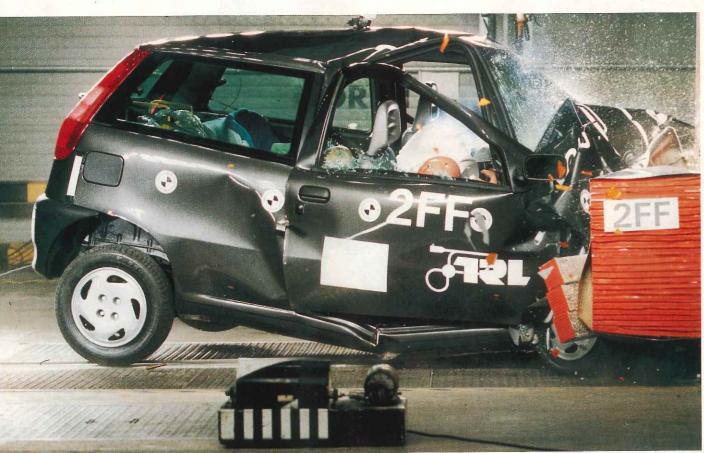
impact: head contact on the airbag was unstable and the passenger compartment became unstable due to weld failure of the A pillar and facia attachment

frontal impact, the Punto's enger compartment became ble owing to failure of the welds on the front door pillar he partial detachment of the Structural deformation was rate. The driver's door

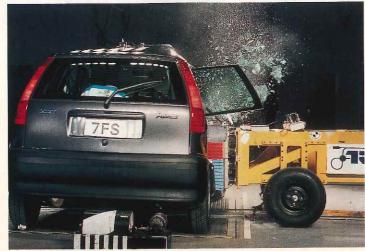
All the new side impact criteria were met but chest protection was weak

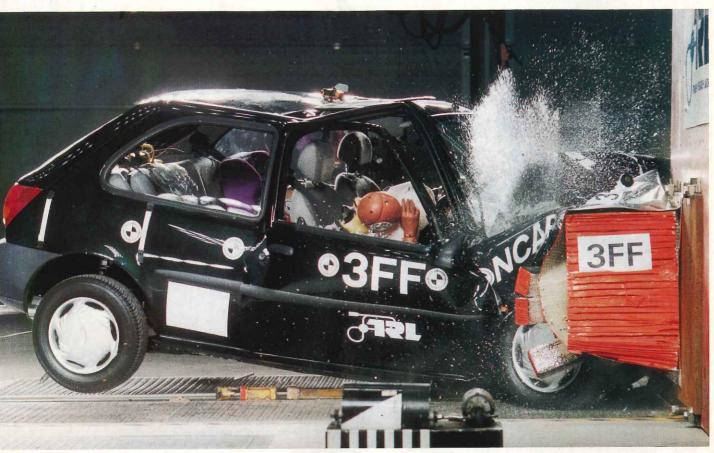
e was stable head contact on the airbag in the frontal impact crash test, during which the Ford Fiesta's passenger compartment maintained its stability

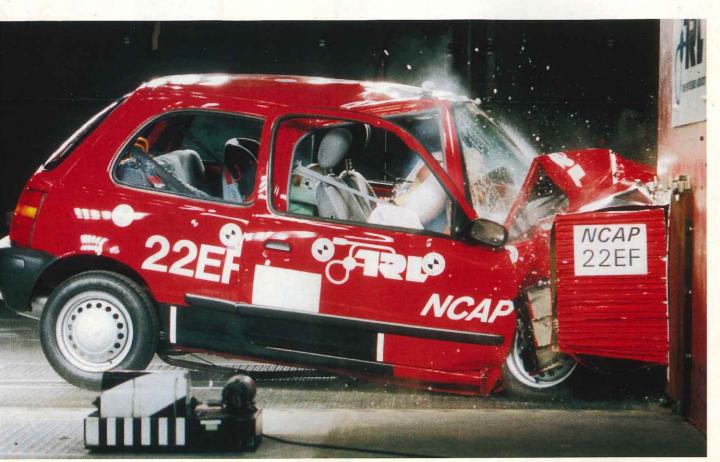
was stable head contact on the driver's airbag and the Nissan Micra's passenger compartment maintained its stability during the frontal impact crash test

The driver's door failed to transmit loads effectively, allowing a moderate collapse of the door aperture and also intrusion of the facia.

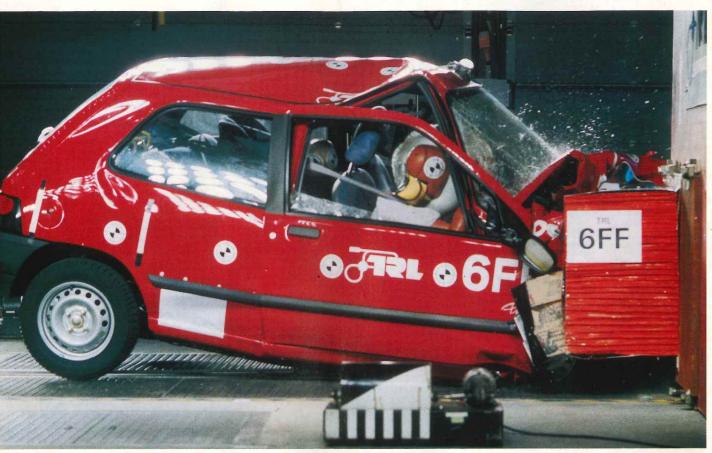
lio driver's head slid off the airbag and scuffed the windscreen pillar. The passenger compartment became unstable because of failure of welds attaching the facia

instability of the passenger partment was caused by the al detachment of the facia the side of the car. Actual

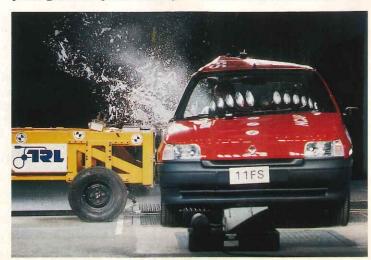
In side impact the Renault Clio failed to meet the new criteria for chest protection

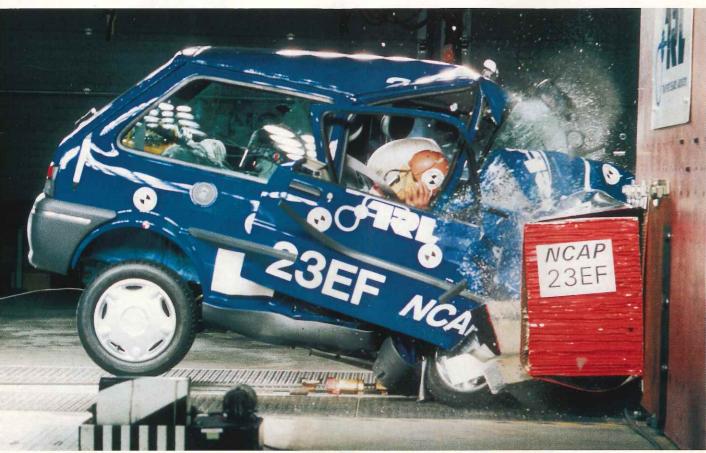
d contact with the airbag was unstable and the head struck the windscreen pillar. Passenger compartment deformation was excessive and it became unstable

The Rover suffered excessive deformation of the passenger compartment in the frontal

impact – the A-pillar on the driver's side was pushed back by 488mm – and the structure became unstable. This was because the driver's door split apart, allowing excessive collapse of the door aperture and intrusion of the facia, which had partially come away from the car's side.

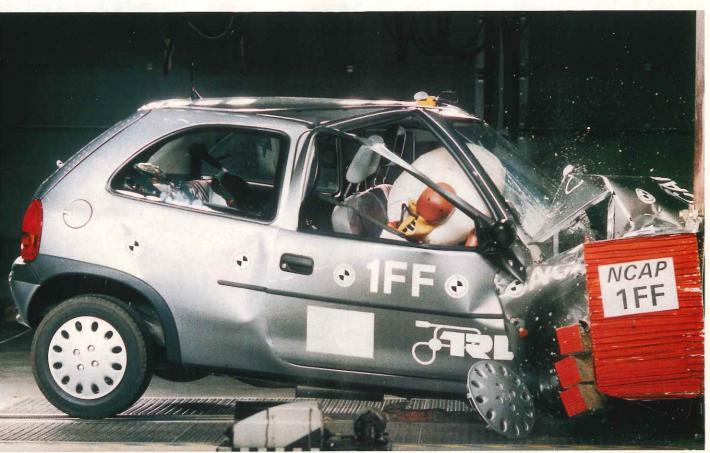
was stable head contact on the Corsa's airbag and the passenger compartment maintained its stability in frontal impact. The passenger's head hit the facia top

The passenger's head impacted on the top of the facia and the protection level was assessed as poor. Since this result was worse than that for the driver, it was used in calculating the overall protection rating in frontal and side impact.

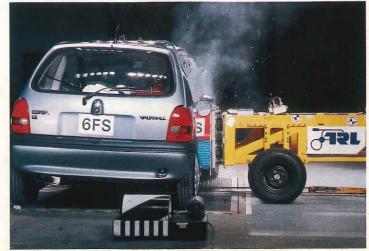
All the new side impact criteria were met but abdomen protection was weak

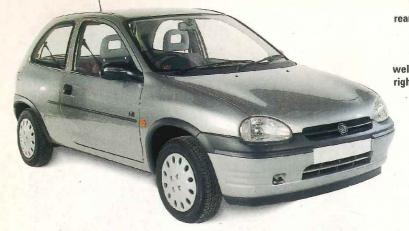
There was limited rearward and upward movement of the steering wheel. The left knee was well protected but the right knee hit the fuse box cover

On the right side, however, the knee hit the fuse box cover which was supported by a strut and tubular bar. Protection was downrated to poor since further penetration on this side would have resulted in sharply increased loads.

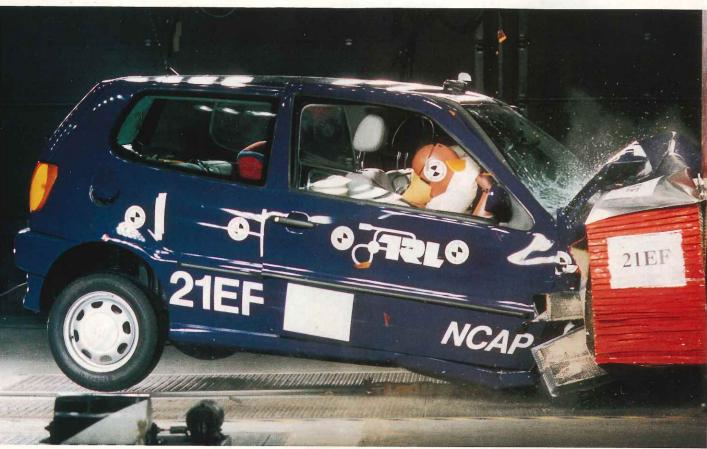
was stable head contact on the airbag in frontal impact and the VW Polo's passenger compartment maintained its stability with only limited intrusion

87mm upwards. Collapse of the door aperture and intrusion of the facia were also found to be of limited extent.

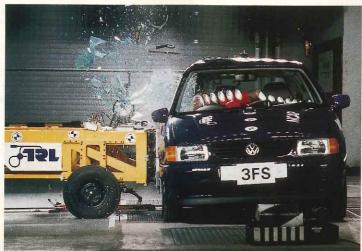
The new side impact criteria for chest protection were not met by the VW Polo
