VW up!
Standard Safety Equipment

2019

Tested Model	VW e-up! 'Move Up', LHD
Body Type	- 5 door hatchback
Year Of Publication	2019
Kerb Weight	1164kg
VIN From Which Rating Applies	- all VW up!s
Class	Supermini

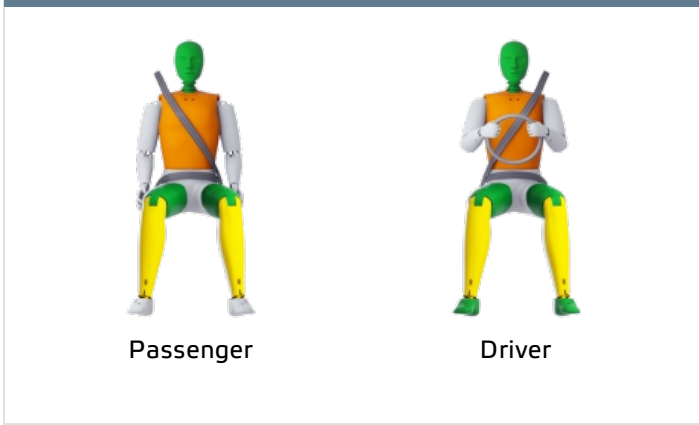
Frontal Offset Deformable Barrier 6.6 / 8 Pts

Detailed description: This panel shows two side-view illustrations of a crash test dummy seated in a car. The dummy is wearing a seatbelt. The left dummy is labeled 'Passenger' and has a green head and torso with yellow legs. The right dummy is labeled 'Driver' and has a green head and torso with yellow legs. The background is white.

The passenger compartment of the up! remained stable in the frontal offset test. Dummy readings indicated good protection of the knees and femurs of the driver and passenger. VW showed that a similar level of protection would be provided to occupants of different sizes and to those sitting in different positions. Chest protection of both dummies was marginal. In the full-width rigid barrier test, protection of the chest was again marginal for both occupants, with other critical body areas well or adequately protected. In the side barrier impact, all critical body areas were well protected and the up! scored maximum points in this test. In the more severe side pole test, protection of the chest was adequate and that of other body areas was good. Tests on the front seats and head restraints demonstrated good protection against whiplash injuries in the event of a rear-end collision. A geometric assessment of the rear seats indicated marginal whiplash protection. An autonomous emergency braking (AEB) system is not available on the up!

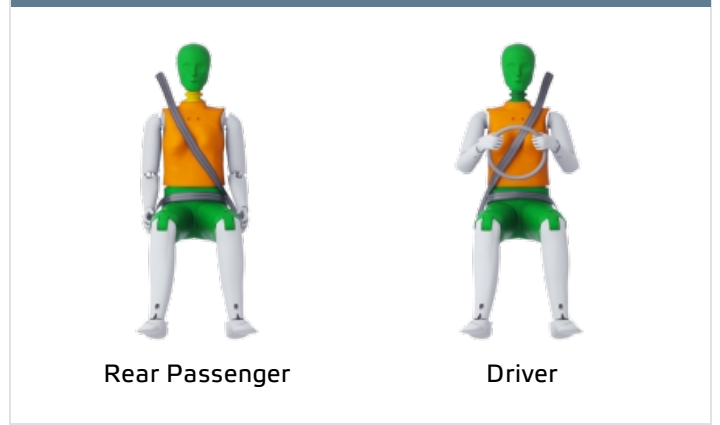
Frontal Full Width 7.1 / 8 Pts

Detailed description: This panel shows two side-view illustrations of a crash test dummy seated in a car. The dummy is wearing a seatbelt. The left dummy is labeled 'Rear Passenger' and has a green head and torso with orange legs. The right dummy is labeled 'Driver' and has a green head and torso with orange legs. The background is white.

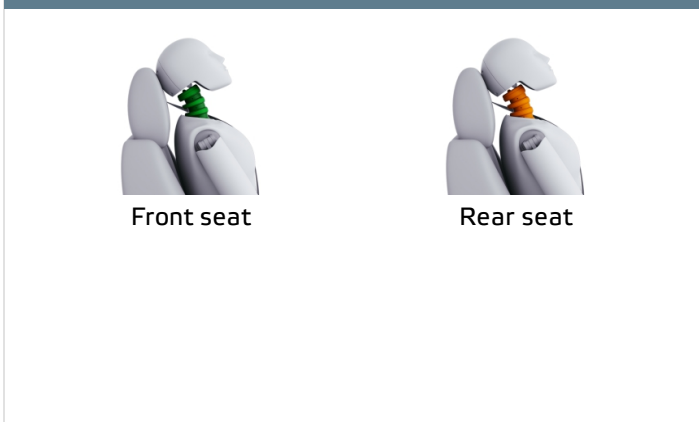
Whiplash Rear Impact 1.4 / 2 Pts

Detailed description: This panel shows two rear-view illustrations of a crash test dummy's head and neck. The left illustration is labeled 'Front seat' and shows the dummy's head tilted back with a green neck. The right illustration is labeled 'Rear seat' and shows the dummy's head tilted forward with an orange neck. The background is white.

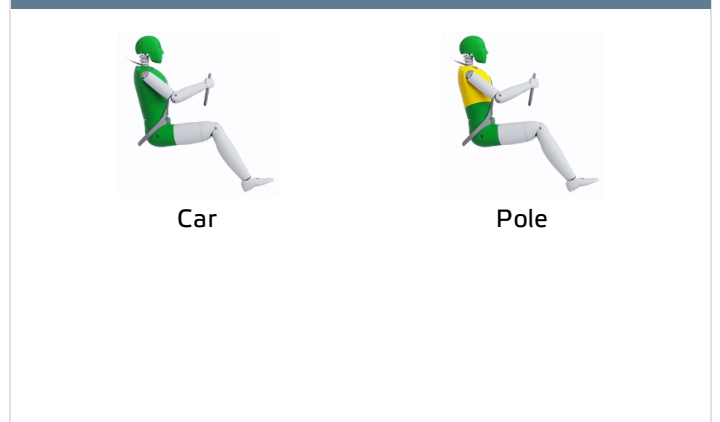
Lateral Impact 15.7 / 16 Pts

Detailed description: This panel shows two side-view illustrations of a crash test dummy seated in a car. The dummy is wearing a seatbelt. The left illustration is labeled 'Car' and shows the dummy's head tilted back with a green torso. The right illustration is labeled 'Pole' and shows the dummy's head tilted forward with a yellow torso. The background is white.
