Dacia Logan

Standard Safety Equipment

2021

Tested Model	Dacia Sandero Stepway 1.0TCe, LHD
Body Type	- 5 door hatchback
Year Of Publication	2021
Kerb Weight	1111kg
VIN From Which Rating Applies	- all Logans
Class	Small Family Car

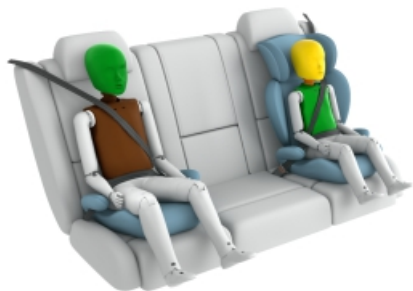
Frontal Impact

10.6 Pts

In the frontal offset test, protection of the chest and neck of the 10 year dummy was rated as weak, based on dummy readings during the impact. For the 6 year dummy, protection of the neck was marginal while that of the head and chest was adequate and good respectively. The front passenger airbag can be disabled to allow a rearward-facing child restraint to be used in that seating position. Clear information is provided to the driver regarding the status of the airbag and the system was rewarded. All of the child restraints for which the car is designed could be properly installed and accommodated. One, a full sized rearward facing toddler restraint, could be fitted in the car with no problem but was deemed a fail because Dacia indicate in the user manual that the car cannot accommodate this (R3) category of restraint.
