Dacia Sandero Stepway
Standard Safety Equipment

2021

SPECIFICATION

Tested Model	Dacia Sandero Stepway 1.0TCe, LHD
Body Type	- 5 door hatchback
Year Of Publication	2021
Kerb Weight	1111kg
VIN From Which Rating Applies	- all Sanderos and Sandero Stepways
Class	Supermini

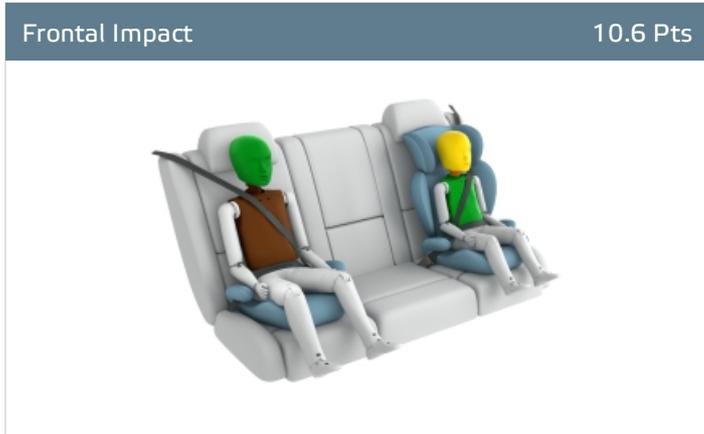
Crash Test Performance based on 6 & 10 year old children

18.6 / 24 Pts

Restraint for 6 year old child: *Britax Römer KidFix XP*
 Restraint for 10 year old child: *Britax Römer KidFix XP (Booster only)*

In the frontal offset test, protection of the chest and neck of the 10 year dummy was rated as weak, based on dummy readings during the impact. For the 6 year dummy, protection of the neck was marginal while that of the head and chest was adequate and good respectively. The front passenger airbag can be disabled to allow a rearward-facing child restraint to be used in that seating position. Clear information is provided to the driver regarding the status of the airbag and the system was rewarded. All of the child restraints for which the Sandero Stepway is designed could be properly installed and accommodated. One, a full sized rearward facing toddler restraint, could be fitted in the car with no problem but was deemed a fail because Dacia indicate in the user manual that the car cannot accommodate this (R3) category of restraint.

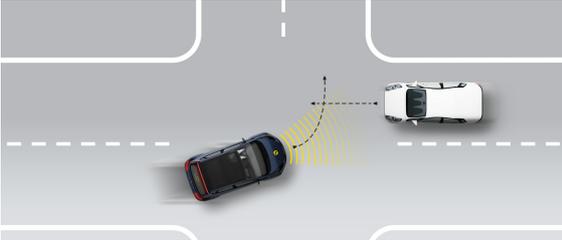
Test car turns across the path of an approaching car

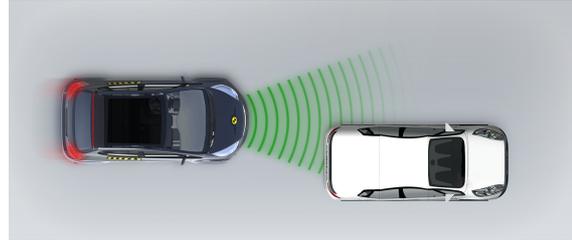
Approaching a stationary car

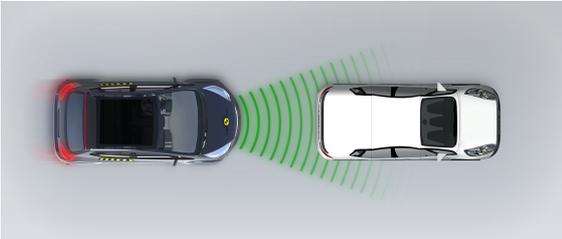
Approaching a stationary car

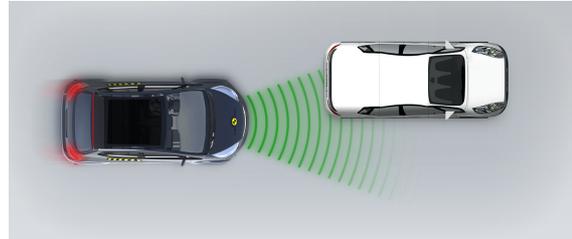
Approaching a stationary car

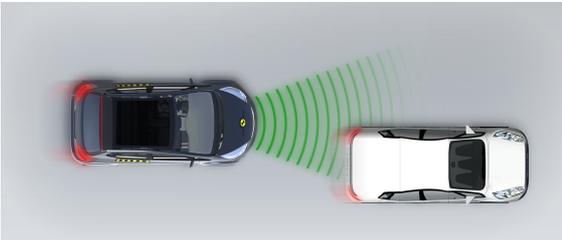
Approaching a slower moving car

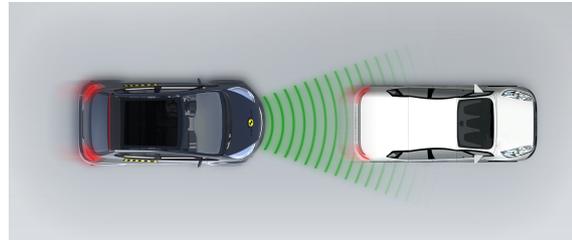
Approaching a slower moving car

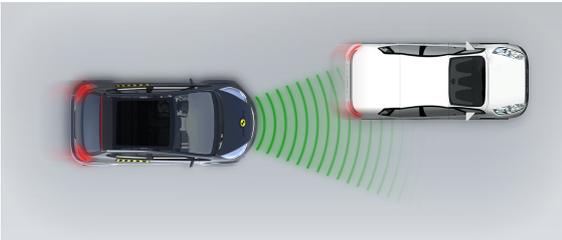
Approaching a slower moving car

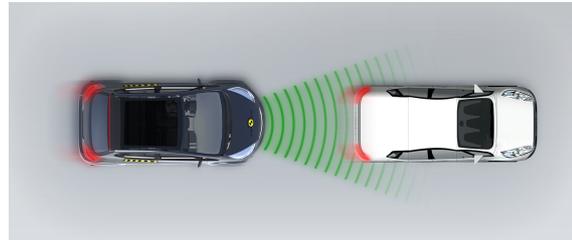
Approaching a braking car

A seatbelt reminder system is standard for the front and rear seats. A driver-set speed limiter is also standard but the Sandero Stepway provides no lane assistance. The AEB system performed well in tests of its response to other vehicles with accidents avoided or mitigated in many cases.

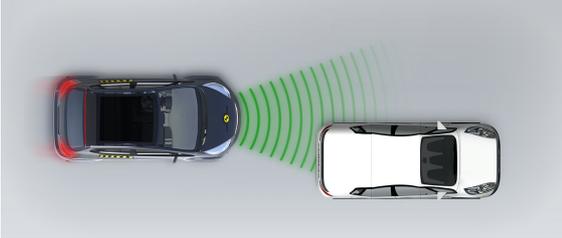
Approaching a stationary car

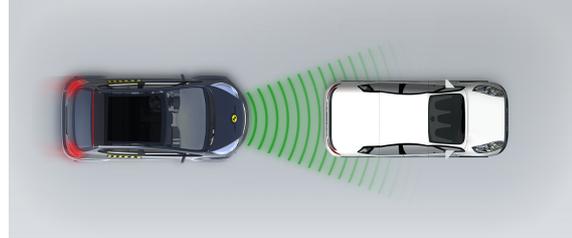
Approaching a stationary car

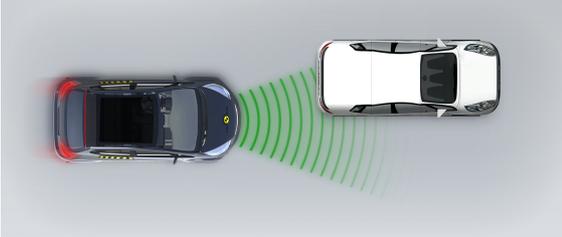
Approaching a stationary car

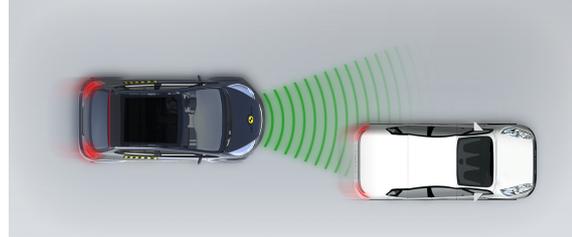
Approaching a slower moving car

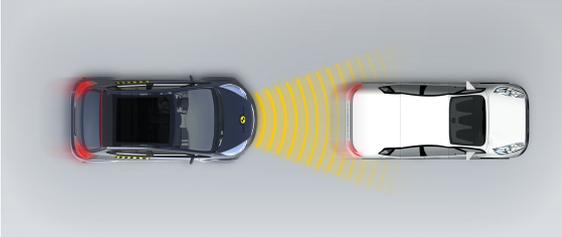
Approaching a slower moving car

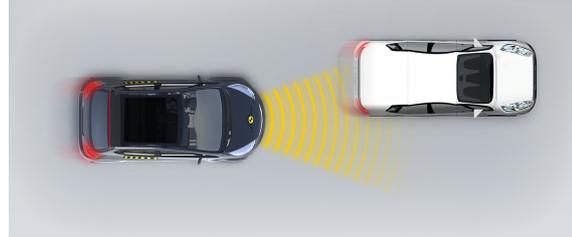
Approaching a slower moving car

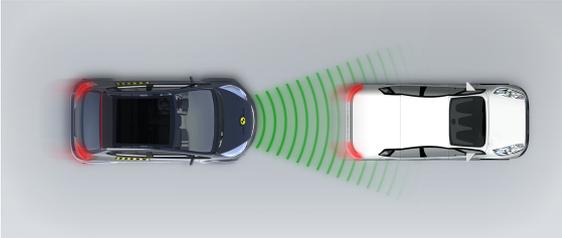
Approaching a braking car
