CUPRA Leon

Standard Safety Equipment

2020

The CUPRA Leon is a 'twin' of the SEAT Leon tested by Euro NCAP in 2020. Some additional whiplash tests have been done to check that whiplash performance is the same, and that the installation of child restraints is unaffected. Otherwise, the results are carried over from the SEAT Leon and the CUPRA shares the 2020 star rating.

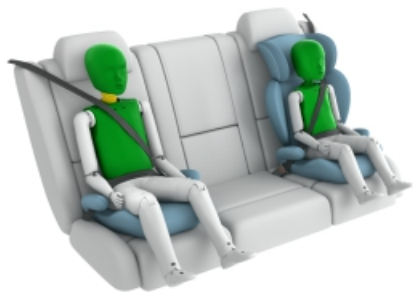
Frontal Impact

15.4 Pts

In the frontal offset test, protection of both child dummies was good except for the neck of the 10 year dummy, protection of which was adequate. In the side barrier test, protection of all critical body regions was good and the Leon scored maximum points for this part of the assessment. The front passenger airbag can be disabled to allow a rearward-facing child restraint to be used in that seating position. Clear information is provided to the driver regarding the status of the airbag and the system was rewarded. All of the restraints for which the Leon is designed could be properly installed and accommodated.

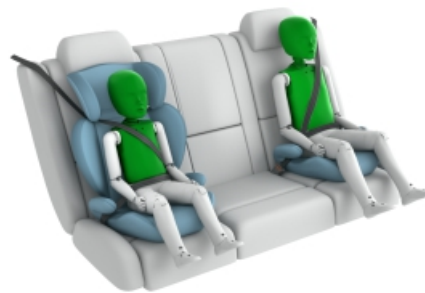
Lateral Impact

8 Pts
