Opel Ampera

Opel/Vauxhall Ampera 1.4/electric, LHD

2011

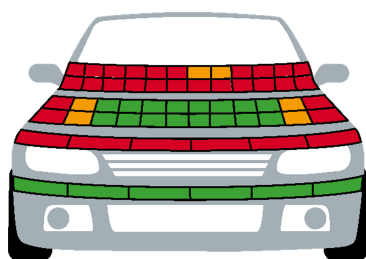
GOOD
MARGINAL
POOR

HEAD 8,9 pts
PELVIS 0 pts
LEG 6 pts

The bumper offered good protection to pedestrians' legs and the bonnet was mostly good in those areas likely to be struck by the head of a child. However, no points were scored by the front edge of the bonnet and the bonnet surface offered almost entirely poor protection to the head of a struck adult.
