Audi TT Roadster Sport

2015

SPECIFICATION

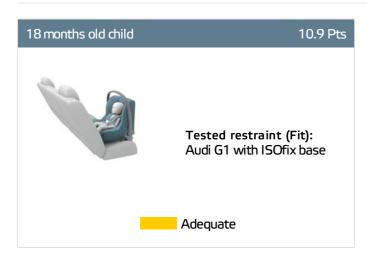
Crash Test Performance 22.9 Pts

There is not sufficient space in the rear seats to use Audi's recommended child restraints when the front seats are in the positions needed to assess adult occupant protection. Separate tests were conducted, with the front seats moved forward, to establish the protection provided to children. Based on those dynamic tests results, the TT scored maximum points for its protection of the 3 year dummy. Both dummies were seated in rearward-facing restraints and, in the side impact, both were properly contained within the protective shells of the restraints, minimising the risk of head contact with parts of the vehicle interior. The front passenger airbag can be disabled to allow a rearward-facing child restraint to be used in that seating position. The rear seats cannot accommodate several categories of child restraint as the upright seating position does not allow for a stable installation.

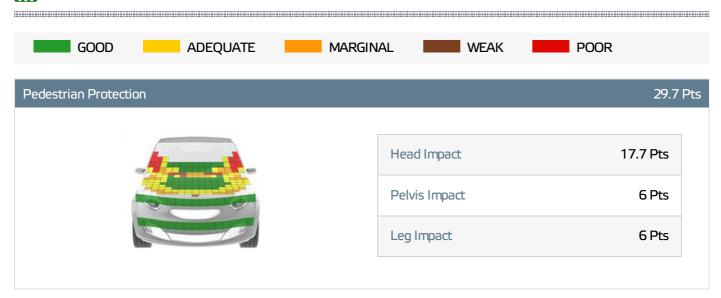
The TT has an 'active' bonnet. Sensors detect when a pedestrian has been struck and actuators lift the bonnet, creating more space between the bonnet surface and the hard structures underneath. Audi showed that the system worked for a broad range of speeds and for many pedestrian statures so the car was tested with the bonnet in the deployed (raised) position. The protection provided to the head of a struck pedestrian was almost entirely good or adequate, with some marginal and poor results recorded on the bonnet edges and the stiff windscreen pillars. The protection provided to pedestrian's legs by the bumper was good in all areas tested, as was that provided by the front edge of the bonnet, both of these areas scoring maximum points in Euro NCAP's tests.
