Peugeot Traveller
Business and Family Van

2015 ★★★★★

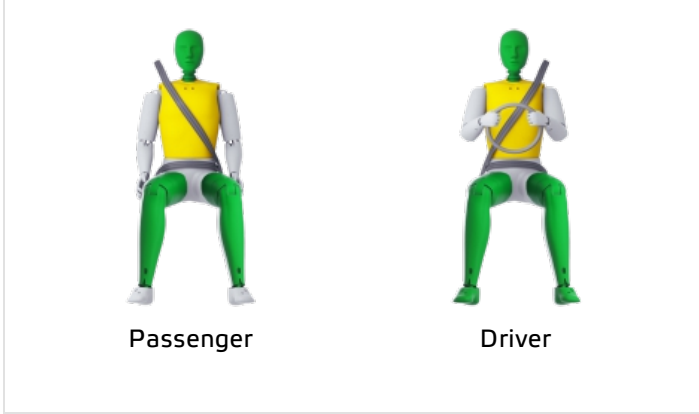
Frontal Offset Deformable Barrier 15.3 Pts

Detailed description: This panel shows the results for the Frontal Offset Deformable Barrier test. It features two side-view illustrations of a crash test dummy. The dummy on the left is labeled 'Passenger' and is wearing a yellow safety vest. The dummy on the right is labeled 'Driver' and is wearing a yellow safety vest and a seatbelt. Both dummies are shown in a seated position, facing forward. The background is white.

The passenger compartment remained stable in the frontal impact. Dummy readings indicated good protection of the knees and femurs of the driver and passenger. Peugeot showed that a similar level of safety would be available to occupants of different sizes and to those sat in different positions. Currently, the full width rigid barrier test is not done on vehicles in the Business and Family Van category. In the side barrier test, the Traveller scored maximum points, with good protection of all body areas. In the more severe side pole impact, dummy readings of rib compression indicated marginal chest protection but the protection of other body areas was rated as good. A geometric assessment indicated good whiplash protection for the front seat occupants but poor whiplash protection for those in the rear.

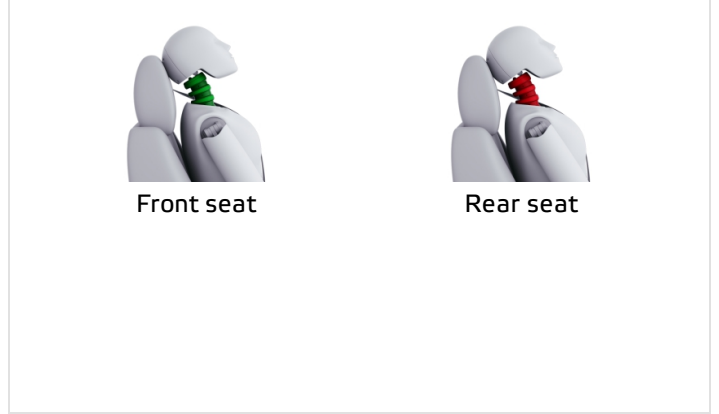
Whiplash Rear Impact 1.6 Pts

Detailed description: This panel shows the results for the Whiplash Rear Impact test. It features two side-view illustrations of a crash test dummy's head and neck. The dummy on the left is labeled 'Front seat' and has a green neck area. The dummy on the right is labeled 'Rear seat' and has a red neck area. Both dummies are shown in a seated position, facing forward. The background is white.

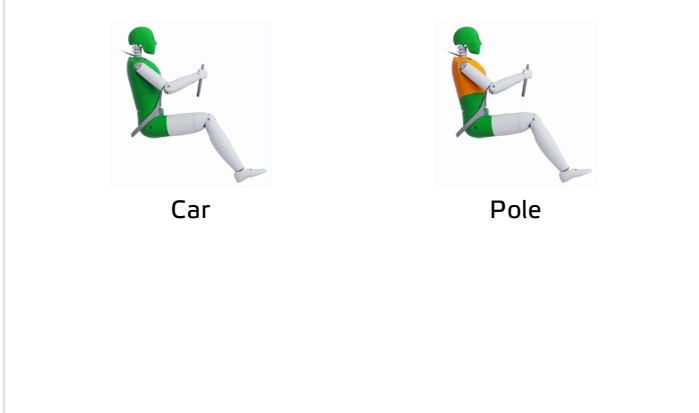
Lateral Impact 14.7 Pts

Detailed description: This panel shows the results for the Lateral Impact test. It features two side-view illustrations of a crash test dummy. The dummy on the left is labeled 'Car' and is wearing a green safety vest. The dummy on the right is labeled 'Pole' and is wearing an orange safety vest. Both dummies are shown in a seated position, facing forward. The background is white.
