Toyota Hilux
Standard Safety Equipment

2016

Tested Model	Toyota Hilux Double-Cab, 2.4 diesel 4x4, mid grade, LHD
Body Type	- Pickup
Year Of Publication	2016
Kerb Weight	2050kg
VIN From Which Rating Applies	- All Hilux double-cabs
Class	Pick-up

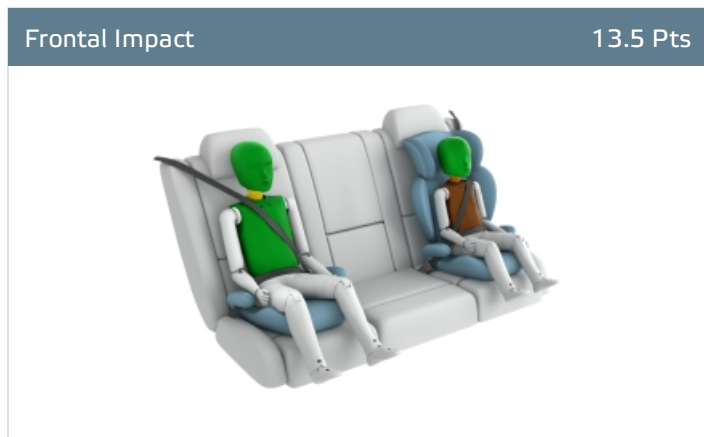
Crash Test Performance based on 6 & 10 year old children

21.5 Pts

Restraint for 6 year old child: *Toyota KidFix XP SICT*

Restraint for 10 year old child: *Graco Junior*

In the frontal offset test, neck tension and chest deceleration revealed, respectively, marginal and weak protection for those body areas in the 6 year dummy. Protection of the 10 year dummy was good, apart from adequate protection of the neck, and, in the side impact was good for all critical body areas for both child dummies. The Hilux has an automatic system for disabling the front passenger airbag when, for example, a rearward-facing child restrain is used in that position. The system met Euro NCAP's requirements and was rewarded. All child restraints for which the Hilux is designed could be accommodated. However, the group 1 ISOFIX seat needed care to ensure correct installation and the rear centre seat is deemed unsuitable for child restraints by Toyota, although restraints could be properly installed there.
