Citroën C3
Standard Safety Equipment

2017

Tested Model	Citroën C3 1,2 PureTech 82 FEEL, LHD
Body Type	- 5 door hatchback
Year Of Publication	2017
Kerb Weight	1072kg
VIN From Which Rating Applies	- all C3s
Class	Supermini

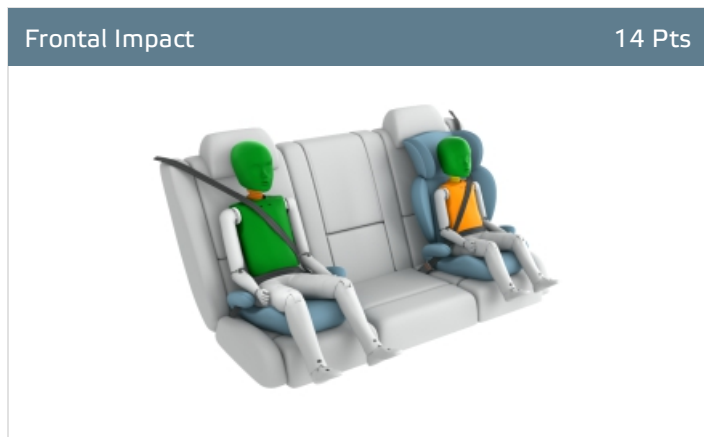
Crash Test Performance based on 6 & 10 year old children

Restraint for 6 year old child: *ROMER Kidfix XP*
 Restraint for 10 year old child: *GRACO booster*

In the frontal offset test, readings of neck tension in the 10 year dummy, and of chest deceleration in the 6 year dummy indicated a marginal level of protection. Otherwise, protection was adequate or good. In the side barrier test, protection was good for all critical parts of the body. The front passenger airbag can be disabled to allow a rearward-facing child restraint to be used in that seating position. Clear information is provided to the driver and the system was rewarded. All of the restraint types for which the C3 is designed could be properly installed and accommodated in the car.
