Reward 2013

Skoda Multi Collision Brake

What is Multi Collision Brake?

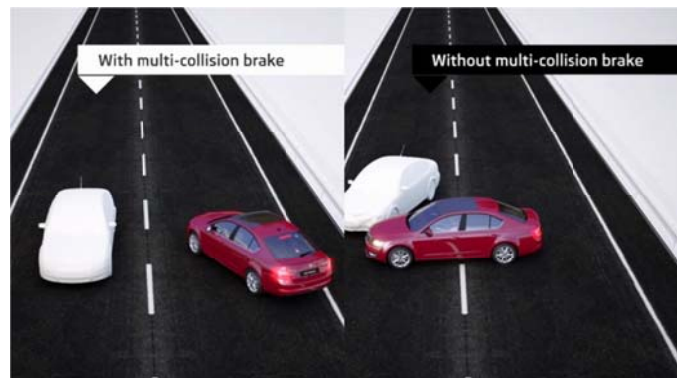
Skoda's Multi Collision Brake is a system that applies the brakes to prevent or mitigate a subsequent impact when a vehicle has been involved in a collision. If the airbag is fired in response to a primary collision, information is sent to the electronic stability control system to brake the vehicle. If the braking system is sufficiently intact to brake safely and effectively, the vehicle is automatically slowed down at a rate of 6ms^{-2} to a speed of 10km/h so that a secondary impact, for instance against another vehicle or roadside object, is avoided or at least less severe. During braking, the hazard warning lights and brake lights are illuminated and the hazard lights remain on after the braking has stopped.

In the event of a serious primary collision, the driver will probably be unable to control the vehicle and Multi Collision Brake acts autonomously to reduce speed safely. Nevertheless, if the driver detects that braking after the initial impact is itself hazardous (for example, increasing the risk of being struck by following traffic), the system can be over-ridden by depressing the accelerator pedal.
