Renault Talisman
Large Family Car

2015 ★★★★★

Tested Model	Renault Talisman 1.5dCi, LHD
Body Type	4 door sedan
Year Of Publication	2015
Kerb Weight	1446kg
VIN From Which Rating Applies	all Talismans
Class	Large Family Car

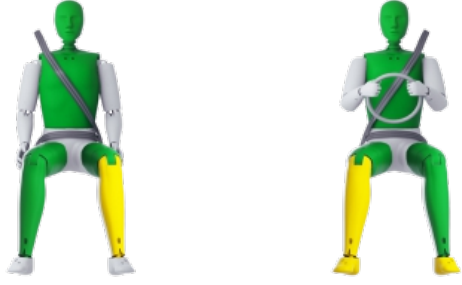
Frontal Offset Deformable Barrier 7.7 Pts

The passenger compartment of the Talisman remained stabled in the frontal impact. Dummy readings indicated good protection of the knees and femurs of the driver and passenger. Renault showed that a similar level of protection would be provided to occupants of different sizes and those sat in different positions. In the side barrier impact, protection of all body critical body regions was good apart from the chest, protection of which was adequate. In the more severe side pole test, dummy readings of rib compression indicated a marginal level of protection for the chest, with good protection of other parts of the body. In Euro NCAP's tests, the front seats and head restraints demonstrated good protection against whiplash injury in the event of a rear-end collision. A geometric assessment of the rear seats indicated good protection also for occupants of those seats. A low-speed autonomous emergency braking system is not available on the Talisman.
