Kia Optima
Large Family Car

2015

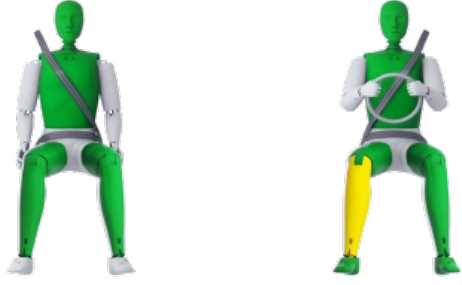
Frontal Offset Deformable Barrier 8 Pts

Passenger Driver

The passenger compartment remained stable in the frontal offset test. The Optima scored maximum points for the protection of the front passenger in that test, with good protection of all critical body areas. Dummy readings indicated good protection of the knees and femurs of both dummies and Kia showed that a similar level of protection would be provided to occupants of different sizes and to those sat in different positions. In the full-width rigid barrier test, protection of the driver was good for all body areas, and for the rear passenger it was good for all areas except the chest, protection of which was adequate. In the side barrier impact, protection of all critical parts of the body was again good, and the Optima scored maximum points. Even in the more severe side pole test, all body areas were well protected. The front seats and head restraints demonstrated marginal protection against whiplash injury in Euro NCAP's tests. A geometric assessment of the rear seats indicated marginal whiplash protection also for the occupants of those seats. An autonomous emergency braking system is available on the Optima which would provide additional whiplash protection at the low, city speeds at which such injuries commonly occur. The system was not included in this assessment as it is not standard equipment.
