**Suzuki Baleno**  
Standard Safety Equipment

2016

## SPECIFICATION

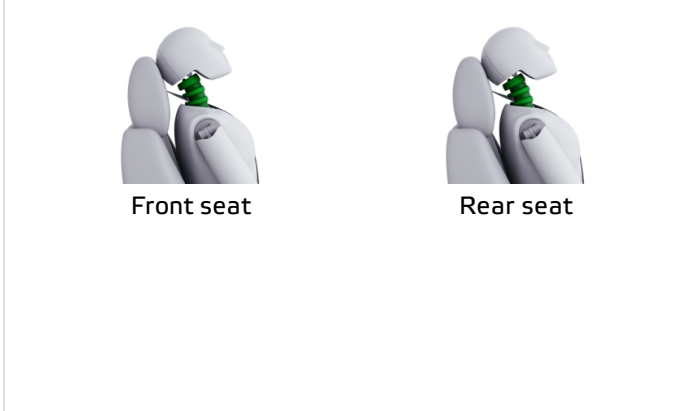
Whiplash Rear Impact 2.6 Pts

Front seat                      Rear seat

Detailed description: This panel shows two crash test dummies from a rear view, seated in a car seat. The Front seat dummy is green and yellow, and the Rear seat dummy is yellow and green. The background is white.
