Citroën C3 Aircross
Standard Safety Equipment

2017

SPECIFICATION

Tested Model	Citroën C3 Aircross Feel Puretech 82, LHD
Body Type	- 5 door MPV
Year Of Publication	2017
Kerb Weight	1126kg
VIN From Which Rating Applies	- all C3 Aircross
Class	Small MPV

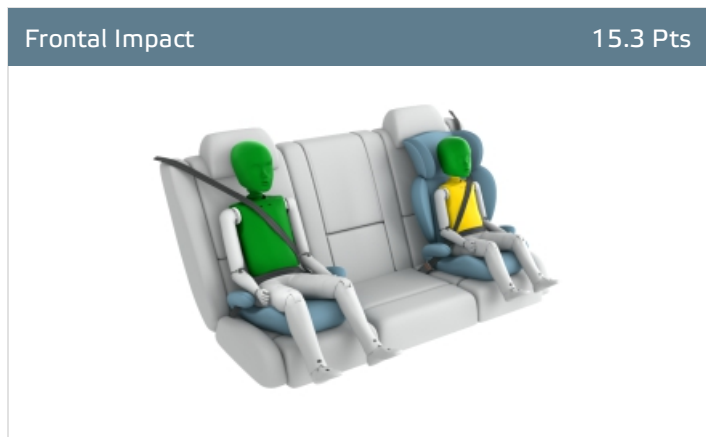
Crash Test Performance based on 6 & 10 year old children

23.3 Pts

Restraint for 6 year old child: *Britax Romer Kidfix XP*

Restraint for 10 year old child: *Graco Booster*

In the frontal offset test, protection of both the 6 and 10 year dummies was good or adequate. In the side barrier test, protection was good for all critical body areas. The front passenger airbag can be disabled to allow a rearward-facing child restraint to be used in that seating position. Clear information is provided to the driver regarding the status of the airbag and the system was rewarded. Universal restraints which use the adult seatbelt should not be used in the rear centre seating position but, otherwise, restraints could be properly installed and accommodated.
