Dacia Duster
Standard Safety Equipment

2017 ★★☆☆☆

Tested Model	Dacia Duster 1.5 diesel, LHD
Body Type	- 5 door SUV
Year Of Publication	2017
Kerb Weight	1303kg
VIN From Which Rating Applies	- all Dusters
Class	Small Off-Road

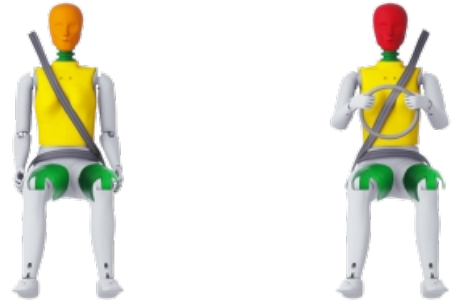
Frontal Full Width 3.4 Pts

The passenger compartment of the Duster remained stable in the frontal offset test. Dummy readings indicated good protection of the knees and femurs of both the driver and passenger but structures in the dashboard on the driver's side were thought to present a risk of injury to occupants of different sizes and to those sat in different positions. In the full-width rigid barrier test, head injury values based on decelerations indicated poor protection for this part of the body and all points for the driver dummy were lost. Dummy readings for the head of the rear passenger were good, but it moved too far forward in the test, and protection was rated as marginal. In the side barrier test, the Duster provided good protection to all critical body areas and scored maximum points. Even in the more severe side pole test, protection of the chest was adequate and that of other body areas was good. Tests on the front seats and head restraints demonstrated marginal protection against whiplash injuries in the event of a rear-end collision. A geometric assessment of the rear seats also indicated marginal whiplash protection.

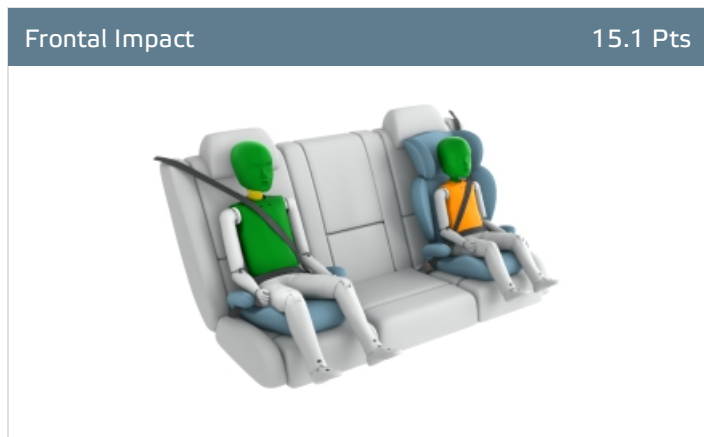
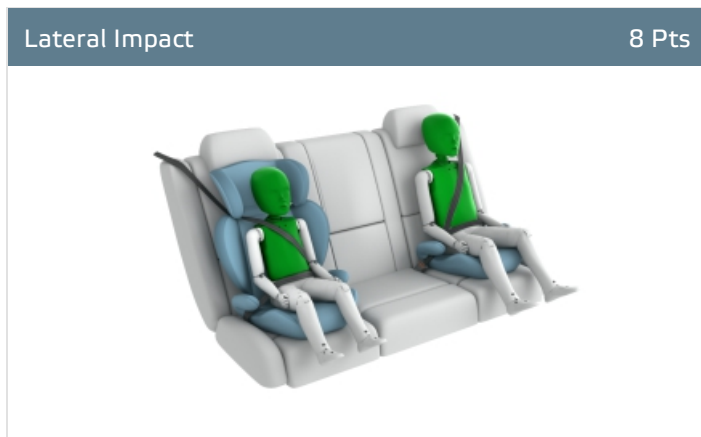
Crash Test Performance based on 6 & 10 year old children

In the frontal offset test, dummy readings in the 6 year dummy indicated marginal chest protection but, otherwise, protection was good or adequate for both dummies. In the side barrier test, protection of all critical parts of the body was good for both child dummies. The front passenger airbag can be disabled to allow a rearward-facing child restraint to be used in that seating position. Clear information is provided to the driver regarding the status of the airbag and the system was rewarded. The marking of ISOFIX/i-Size anchorages in the rear outboard seats did not meet Euro NCAP's requirements so the installation check of all such restraints is indicated as a partial fail, although the restraints could be installed and accommodated in the car. Universal restraints are not allowed in the front passenger seat so the installation checks are deemed to have failed.
