SsangYong Korando
Standard Safety Equipment

2019

Tested Model	SsangYong Korando 1.6 diesel, LHD
Body Type	- 5 door SUV
Year Of Publication	2019
Kerb Weight	1728kg
VIN From Which Rating Applies	- all Korandos
Class	Small Family Car

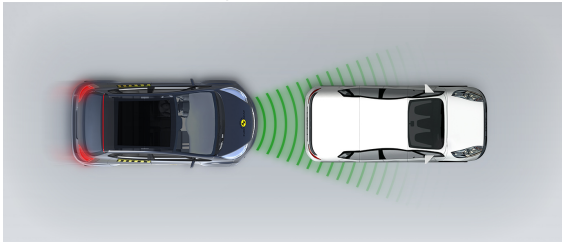
Approaching a stationary car: No Offset

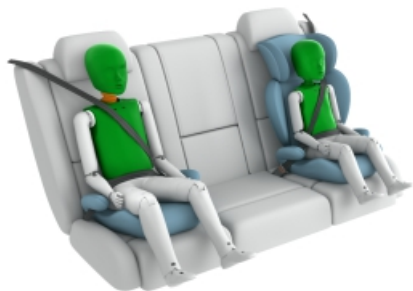
Frontal Impact

14.8 Pts

In the frontal offset test, protection of the six-year dummy was good for all critical body areas. For the ten-year-old, dummy readings of neck tension indicated marginal protection for this body region, but protection elsewhere was good. In the side barrier test, protection of all critical parts of the body was good for both child dummies. The front passenger airbag can be disabled to allow a rearward-facing child restraint to be used in that seating position. Clear information is provided to the driver regarding the status of the airbag and the system was rewarded. All restraint types for which the Korando is designed could be properly installed and accommodated in the car.

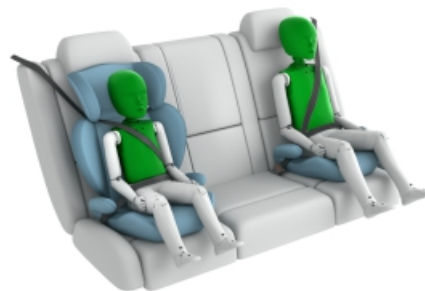
Lateral Impact

8 Pts

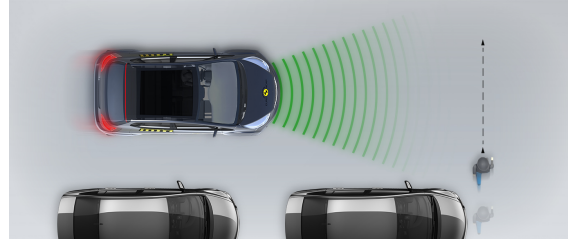
Child running from behind parked vehicles

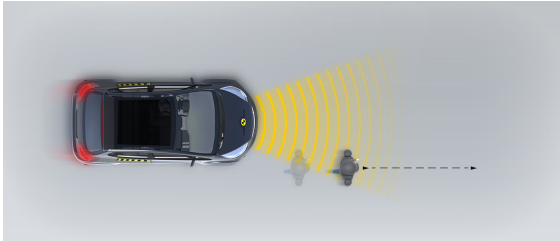
Adult along the roadside

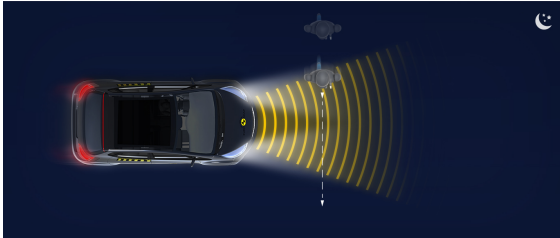
Adult crossing the road

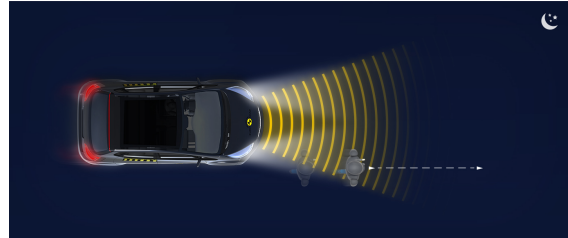
Adult along the roadside

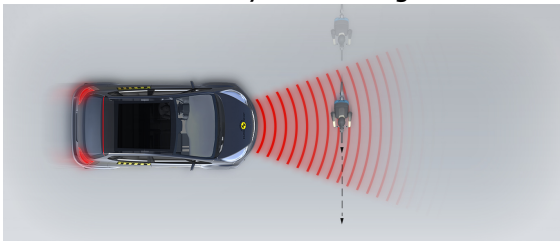
Cyclist crossing

The protection provided to the head of a struck pedestrian was good or adequate over most of the bonnet surface, with poor results recorded at the base of the windscreen and on the stiff windscreen pillars. Protection of pedestrians' legs was good at all test locations but protection of the pelvis was mixed. The AEB system of the Korando can detect vulnerable road users like pedestrians and cyclists, as well as other vehicles. In tests of its response to pedestrians, the system performed adequately. The system's reaction to cyclists was rated as marginal.

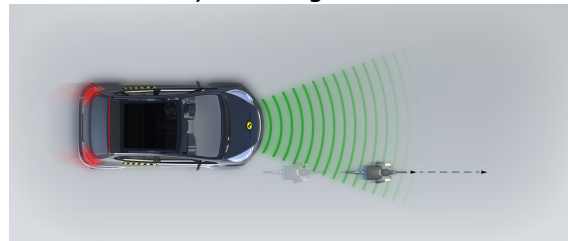
Cyclist along the roadside

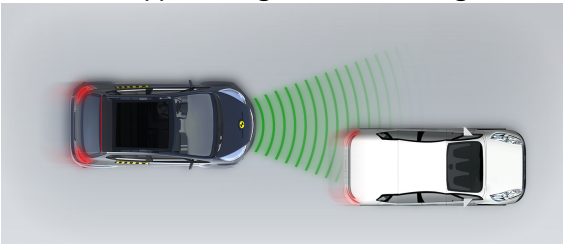
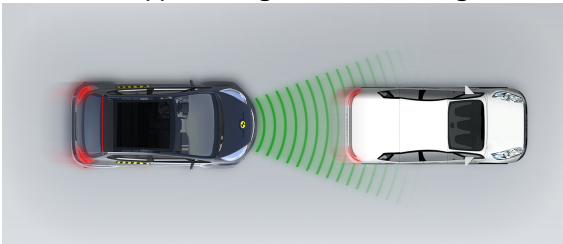
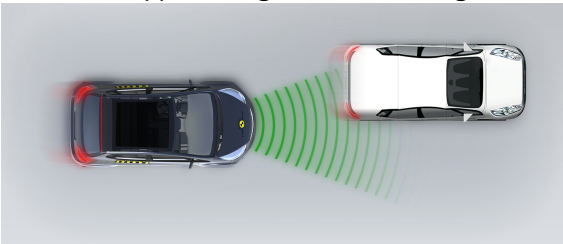
Approaching a slower moving car

The AEB system performed well in tests of its response to other vehicles at highway speeds, with collisions avoided in almost all test scenarios. A seatbelt reminder system is standard for the front and rear seats. A camera-based speed limit recognition system presents the information the driver, allowing the speed limiter to be set appropriately. The lane support system helps to prevent inadvertent drifting out of lane and also intervenes more aggressively in certain critical situations.

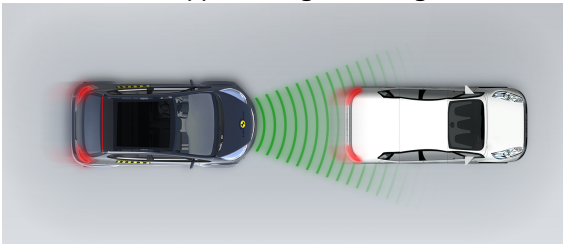
Approaching a braking car

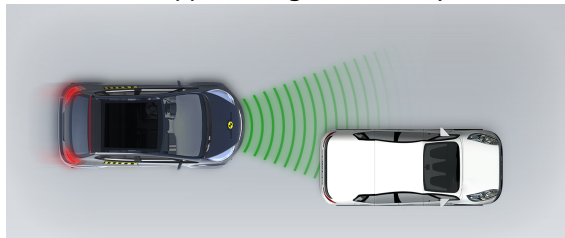
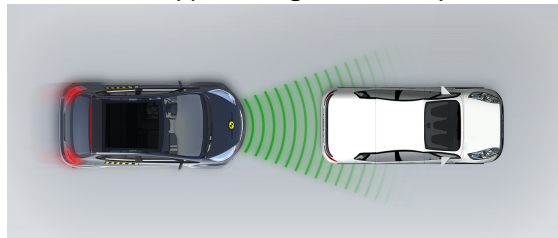
Approaching a stationary car

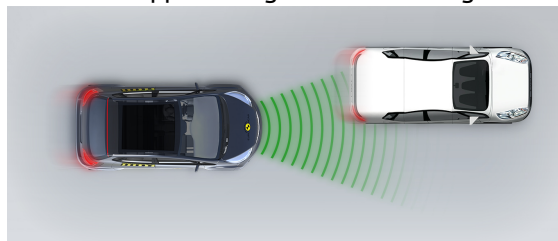
Approaching a slower moving car
