Peugeot 208
Standard Safety Equipment

2019

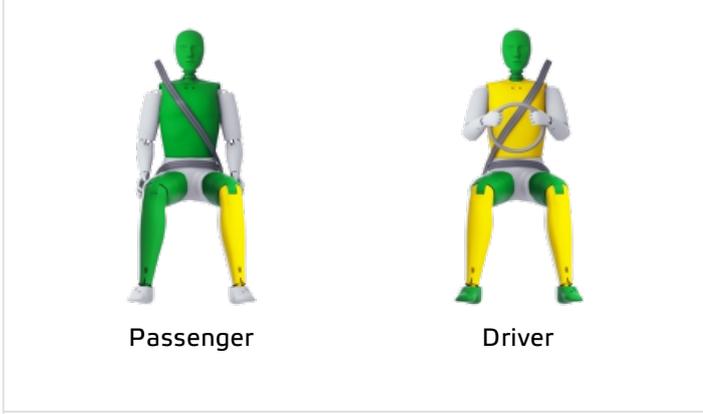
Frontal Offset Deformable Barrier 7.5 / 8 Pts

Detailed description: This panel shows the results for the Frontal Offset Deformable Barrier test. It features two side-view illustrations of crash test dummies. The Passenger dummy is colored green, indicating a 'GOOD' result. The Driver dummy is colored yellow, indicating an 'ADEQUATE' result.

The passenger compartment of the 208 remained stable in the frontal offset test. Dummy readings showed good protection of the knees and femurs of the driver and passenger. Peugeot demonstrated that a similar level of protection would be provided to occupants of different sizes and to those sitting in different positions. In the full-width rigid barrier test, readings of chest compression in the driver dummy indicated a marginal level of protection for this body area. Otherwise, protection was good or adequate for all critical body regions, for both the driver and rear passenger. In the side barrier test, the 208 scored maximum points with good protection of all critical body areas. In the more severe side pole impact, protection of the chest was marginal and that of other body areas was good. Tests on the front seats and head restraints demonstrated good protection against whiplash injury in the event of a rear-end collision. However, the rear seat row was ineligible for scoring because the centre seat is not equipped with a head restraint on some trim levels. The 208 has autonomous emergency braking (AEB) as standard equipment. In tests against another car at the low speeds, typical of city driving, at which many whiplash injuries occur, the system performed well with collisions avoided or mitigated in all scenarios.

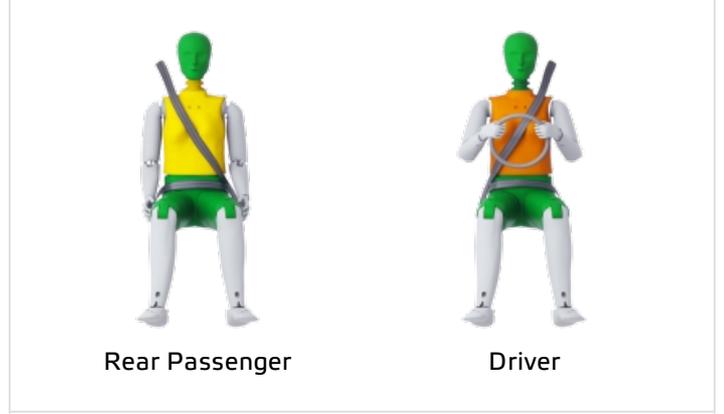
Frontal Full Width 7.4 / 8 Pts

Detailed description: This panel shows the results for the Frontal Full Width test. It features two side-view illustrations of crash test dummies. The Rear Passenger dummy is colored yellow, indicating an 'ADEQUATE' result. The Driver dummy is colored orange, indicating a 'MARGINAL' result.

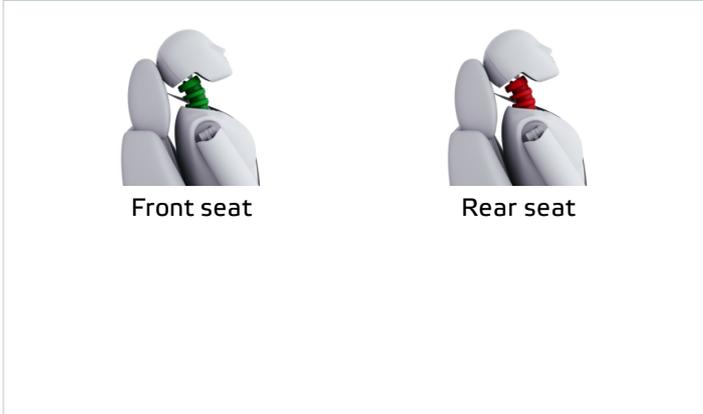
Whiplash Rear Impact 1.2 / 2 Pts

Detailed description: This panel shows the results for the Whiplash Rear Impact test. It features two rear-view illustrations of a car seat. The Front seat is colored green, indicating a 'GOOD' result. The Rear seat is colored red, indicating a 'POOR' result.

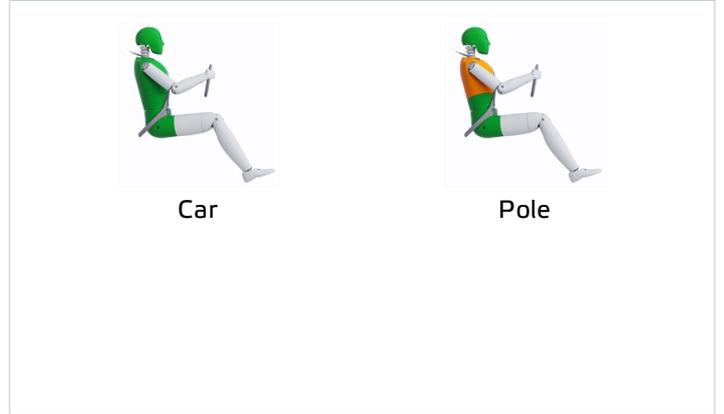
Lateral Impact 15.2 / 16 Pts

Detailed description: This panel shows the results for the Lateral Impact test. It features two side-view illustrations of a crash test dummy. The Car dummy is colored green, indicating a 'GOOD' result. The Pole dummy is colored orange, indicating a 'MARGINAL' result.
