## Peugeot Expert

Asphalt, 2.0 HDI 180

SILVER 2022

SAFETY ASSIST PERFORMANCE

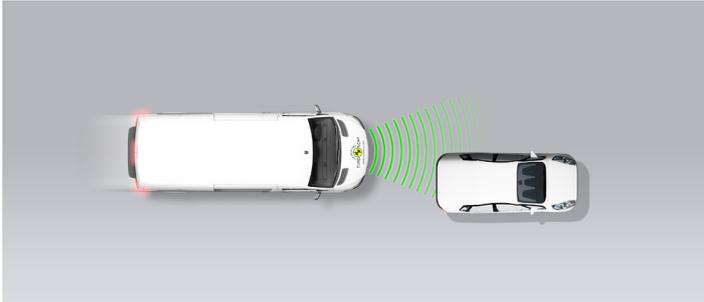
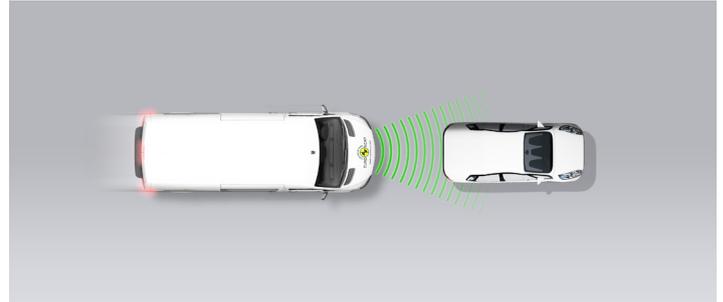
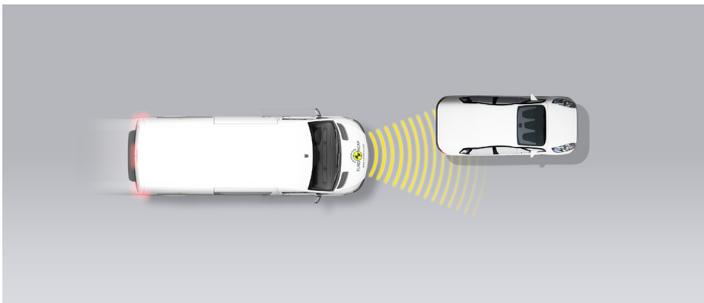
Approaching a stationary car

The Expert is a 'corporate twin' to the Citroën Jumpy and is identically equipped. Autonomous emergency braking (AEB) incorporating forward collision warning (FCW) is one safety option. Up to a certain speed, the system performed well in tests where the Expert was approaching the rear of a stationary car, with collisions avoided or mitigated in most cases. However, at the higher test speeds the FCW did not react. When approaching a slower-moving car, performance was better, and was considered adequate even at the higher test speeds. However, it was noticeable that the AEB/FCW performance was very asymmetric. If the target car was offset significantly to the right/left, good performance was maintained. However, if the target was offset significantly to the right/left, there was no reaction from the system and no degree of collision mitigation. The system showed marginal performance in its response to pedestrians. In the case of a child running from behind parked cars on the nearside, performance was poor. The system does not react to cyclists.

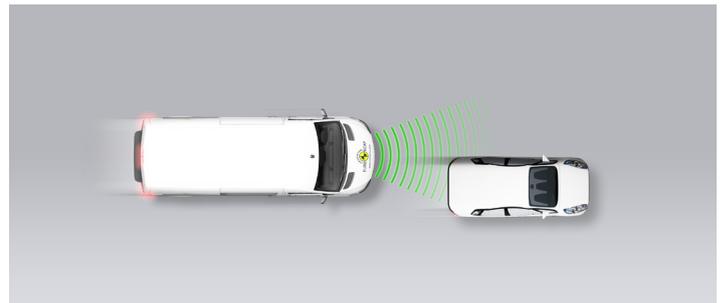
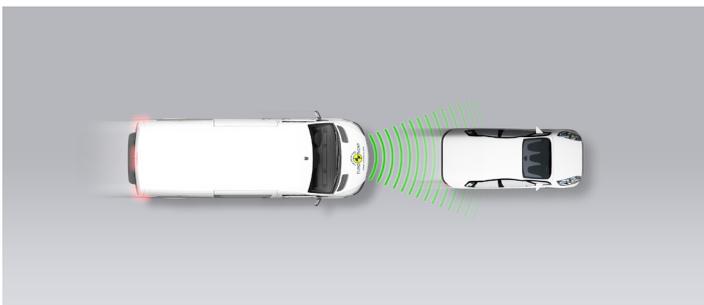
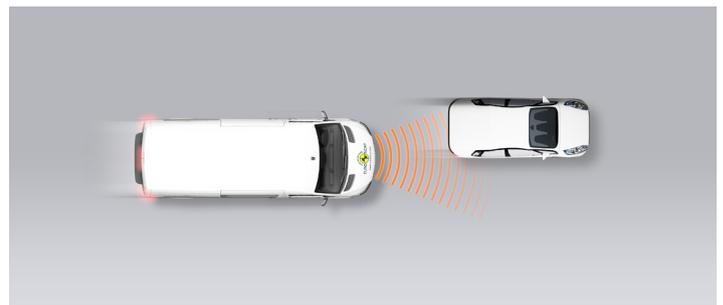
Approaching a slower moving car

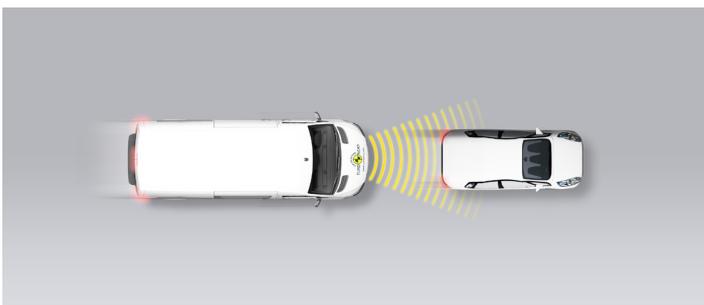
Approaching a braking car

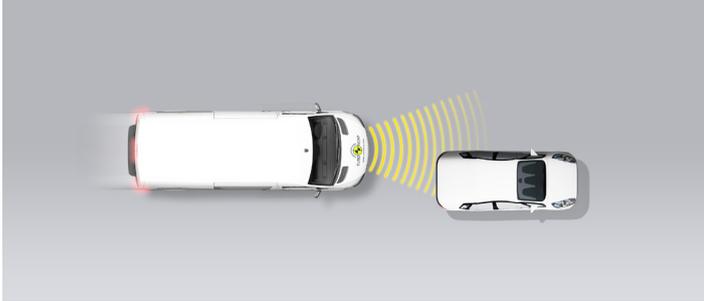
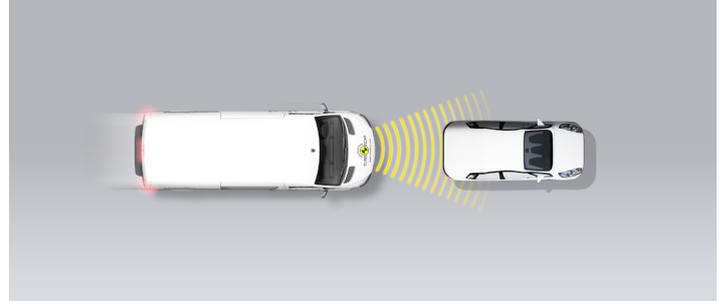
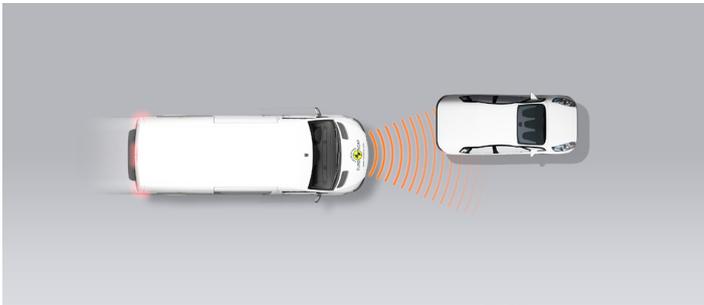
**Driver reacts to warning (Forward Collision Warning - FCW)**

Approaching a stationary car

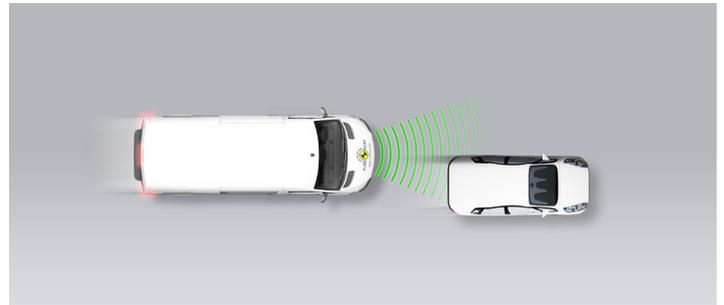
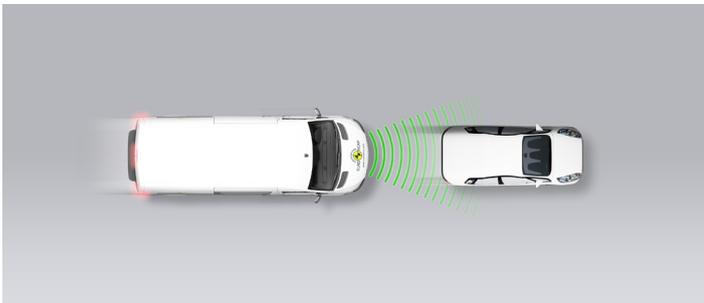
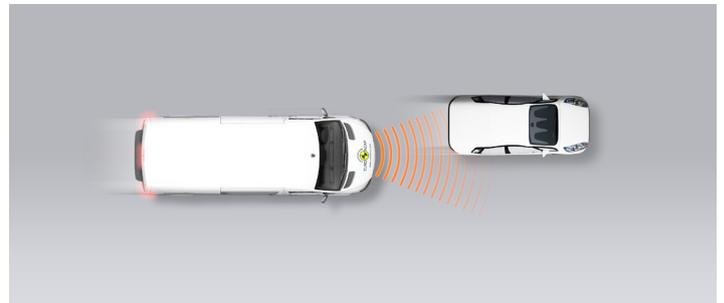
Approaching a slower moving car

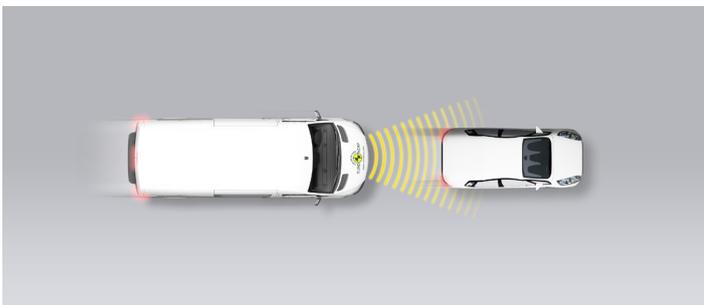
Approaching a braking car

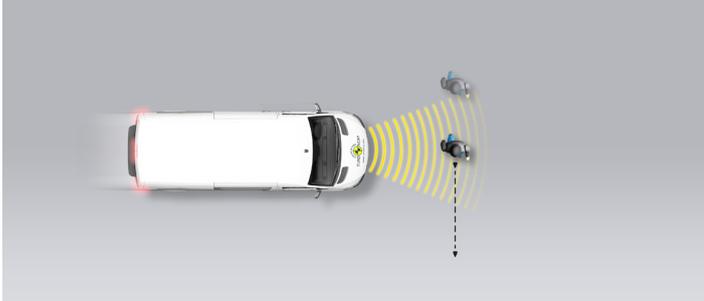
Adult crossing the road

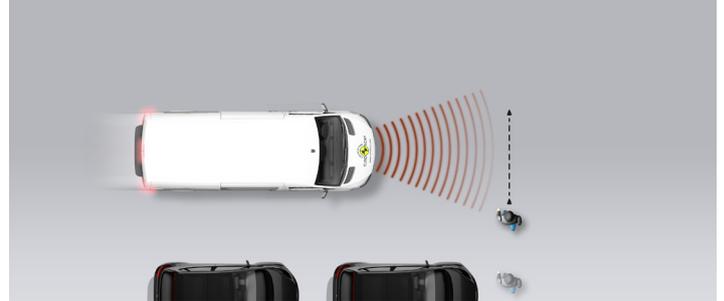
Child running from behind parked vehicles

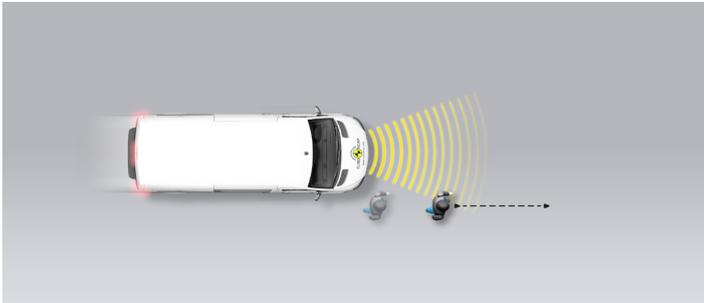
Adult along the roadside

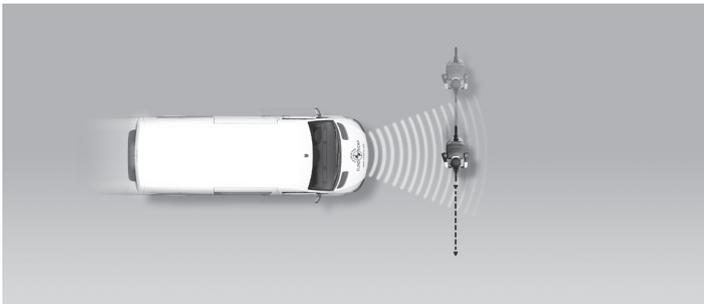
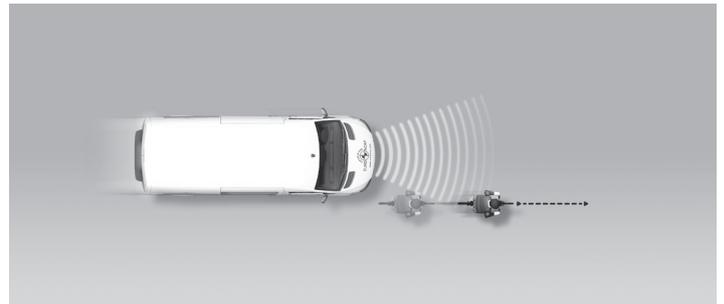
Cyclist crossing

Cyclist along the roadside
