Mercedes-Benz Citan Tourer

Standard Safety Equipment

2022

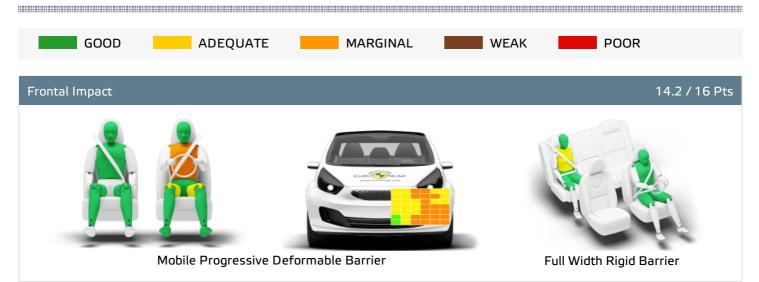
The passenger compartment remained stable in the frontal offset test. Dummy numbers showed good protection of the knees and femurs of both the driver and passenger but a small penalty was incurred for structures in the dashboard on the driver's side which might lead to a reduced level of protection to those of different sizes or sitting in a different position. Protection of the passenger dummy was good for all critical body areas. Analysis of the deceleration of the impact trolley during the test, and analysis of the deformable barrier after the test, revealed that the vehicle would be a benign impact partner in a frontal collision. In the full width rigid-barrier impact, protection of all critical body areas was good for the driver and at least adequate for the rear seat passenger. In the side barrier test, protection of all critical body areas was good and maximum points were scored. In the more severe side pole impact, protection was good or adequate. Control of excursion (the extent to which a body is thrown to the other side of the vehicle when it is hit from the far side) was found to be adequate. The T-Class has a counter-measure to mitigate against occupant to occupant injuries in such impacts and this performed well in Euro NCAP's test. Tests on the front seats and head restraints demonstrated good protection against whiplash injuries in the event of a rear-end collision. A geometric analysis of the rear seats also indicated good whiplash protection. The Citan Tourer has an advanced eCall system which alerts the emergency services in the event of a crash. The car is not equipped a system which applies the brakes after an impact to avoid secondary collisions.

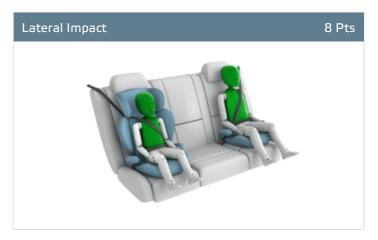
Crash Test Performance based on 6 & 10 year old children

23.8 / 24 Pts

Restraint for 6 year old child: *Britax Römer KIDFIX ²R* Restraint for 10 year old child: *Britax Römer KIDFIX ²R*

In the frontal offset test, protection of all critical body areas was good or adequate, for both the 6 and 10 year dummy. In the side barrier impact, protection of all body areas was good and maximum points were scored. The front passenger airbag is automatically disabled when a rearward-facing child restraint is put in that seating position. Tests showed that the system worked robustly and the system was rewarded. All of the child restraint types for which the car is designed could be properly installed and accommodated.
