Škoda Kodiaq
Standard Safety Equipment

2024

SPECIFICATION

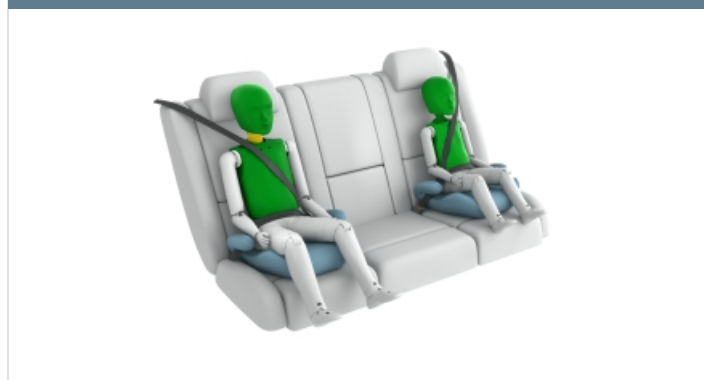
Frontal Impact 15.9 Pts

Crash Test Performance based on 6 & 10 year old children

23.9 / 24 Pts

In the both the frontal offset and side barrier tests, protection was good for all critical body areas of both child dummies apart from the neck of the 10 year dummy, protection of which was adequate. The front passenger airbag can be disabled to allow a rearward-facing child restraint to be used in that seating position. Clear information is provided to the driver regarding the status of the airbag and the system was rewarded. The Kodiaq does not have a child presence detection system, which warns when a child or infant may have been left in the car. All of the child restraint types for which the Kodiaq is designed could be properly installed and accommodated in the car, except for the occasional, foldable third row seats.

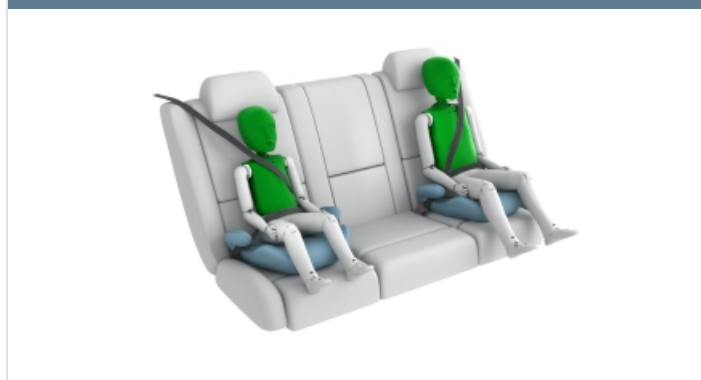
Lateral Impact 8 Pts

Restraint for 6 year old child: *Britax Römer Kidfix i-Size*
 Restraint for 10 year old child: *Britax Römer Kidfix i-Size*
