**Volvo EX30**  
Standard Safety Equipment

2024

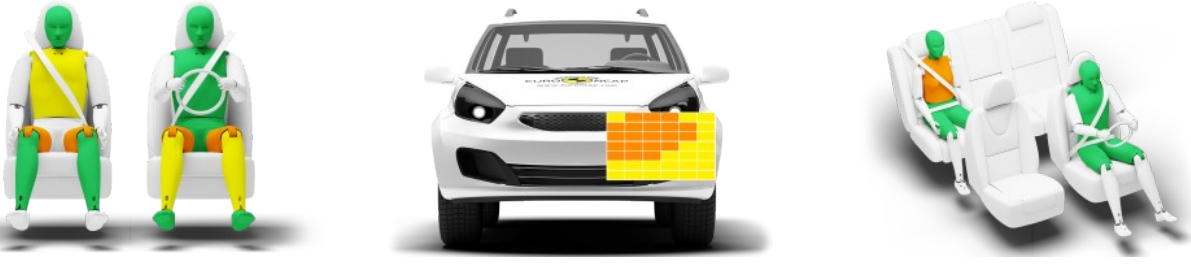
Frontal Impact 13.7 / 16 Pts

Mobile Progressive Deformable Barrier      Full Width Rigid Barrier

The passenger compartment of the Volvo EX30 remained stable in the frontal offset test. Dummy readings indicated good protection of the knees and femurs for the driver and front passenger. Volvo did not demonstrate that a similar level of protection would be provided to occupants of different sizes and to those sitting in different positions, and the car was penalised. Analysis of the deceleration of the impact trolley during the test, and analysis of the deformable barrier after the test, revealed that the Volvo EX30 would be a benign impact partner in a frontal collision. In the full-width rigid barrier test, protection of the chest of the rear passenger was rated as marginal, based on dummy readings of compression. Otherwise, protection was good for the driver and rear passenger. In the side barrier test, full points were scored, with good protection of all critical body regions. In the more severe side pole impact, protection of the chest was weak but that of other parts of the body was good. Control of excursion (the extent to which a body is thrown to the other side of the vehicle when it is hit from the far side) was found to be adequate. The Volvo EX30 has a countermeasure to mitigate against occupant-to-occupant injuries in such impacts. The airbag performed well in Euro NCAP's tests with dummy readings indicating good protection for both the driver and passenger. Tests on the front seats and head restraints demonstrated good protection against whiplash injuries in the event of a rear-end collision. A geometric analysis of the rear seats also indicated good whiplash protection. The car has an advanced eCall system which alerts the emergency services in the event of a crash, and a system to prevent secondary impacts after the car has been in a collision. Volvo demonstrated that the doors and windows would be openable to allow occupants to escape in the event of vehicle submergence.

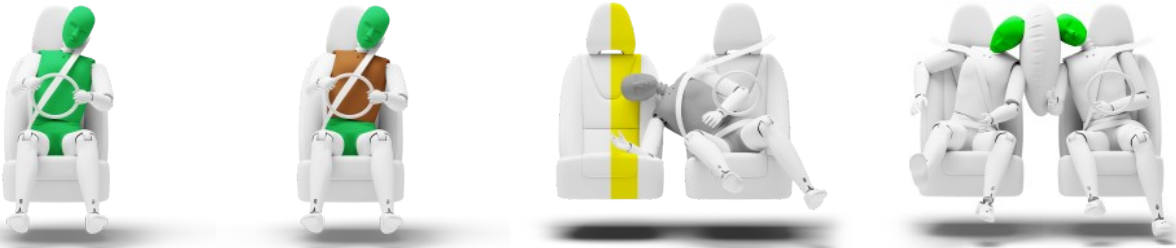
Lateral Impact 15.0 / 16 Pts

Side Mobile Barrier      Side Pole      Far-Side Excursion      Occupant Interaction

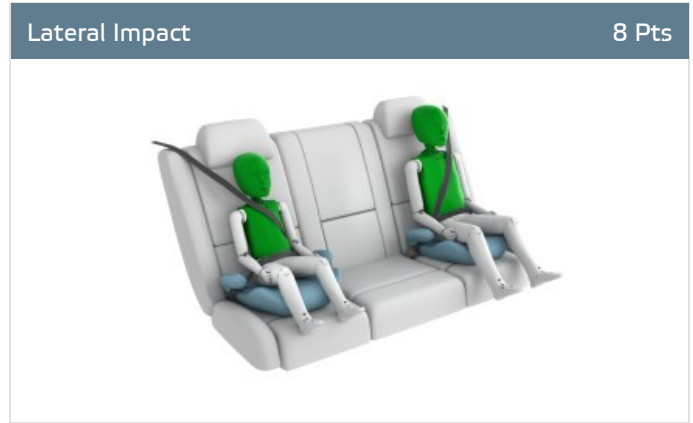
Crash Test Performance based on 6 & 10 year old children

Restraint for 6 year old child: *Volvo Booster Seat*  
 Restraint for 10 year old child: *Volvo Booster Cushion*

In both the frontal offset and side barrier tests, protection of all critical parts of the body was good for the 6 and 10 year dummy, and the Volvo EX30 scored maximum points in this part of the assessment. The front passenger airbag can be disabled to allow a rearward-facing child restraint to be used in that seating position. Clear information is provided to the driver regarding the status of the airbag, and the system was rewarded. The EX30 is not equipped with a 'child presence detection' system, which issues a warning when it recognises that a child or infant may have been left in the car. All of the child restraint types for which the Volvo EX30 is designed could be properly installed and accommodated in the car, apart from the iSize restraint in the rear centre position.
