Chery TIGGO 7  
Standard Safety Equipment

2025

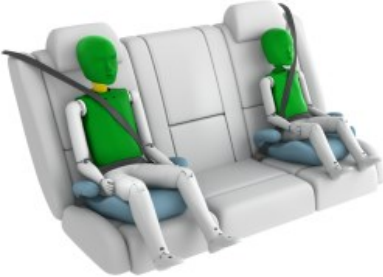
Frontal Impact15.8 Pts

Crash Test Performance based on 6 & 10 year old children 19.8 / 24 Pts

Restraint for 6 year old child: *Britax Römer KidFix i-Size*  
Restraint for 10 year old child: *Graco Booster Max R129*

In the frontal offset test, protection of all critical parts of the body was good or adequate for both the 6 and 10 year dummies. In the side barrier impact test, the curtain airbag became detached from the cant rail and failed to protect the head of the 10 year dummy and readings of acceleration indicated unacceptably high injury values. All points for that dummy were lost in that test. The front passenger airbag can be disabled to allow a rearward-facing child restraint to be used in that seating position. Clear information is provided to the driver regarding the status of the airbag and the system was rewarded. The Chery TIGGO 7 is equipped with an direct 'child presence detection' system, which issues a warning when it recognises that a child or infant may have been left in the car. However, the functionality of the system in terms of the nature and timing of warnings did not meet Euro NCAP's requirements, and no points were awarded. All of the child restraint types for which the Chery TIGGO 7 is designed could be properly installed and accommodated in the car.
